**Flood Control Project Maintenance
Levee Inspections
LMA District Cover Sheet
Spring 2010 Levee Inspection Results**

Reclamation District No. 0556 Upper Andrus

Spring 2010 Levee Inspection Results

Levee Inspection Report By Mile - Spring 2010

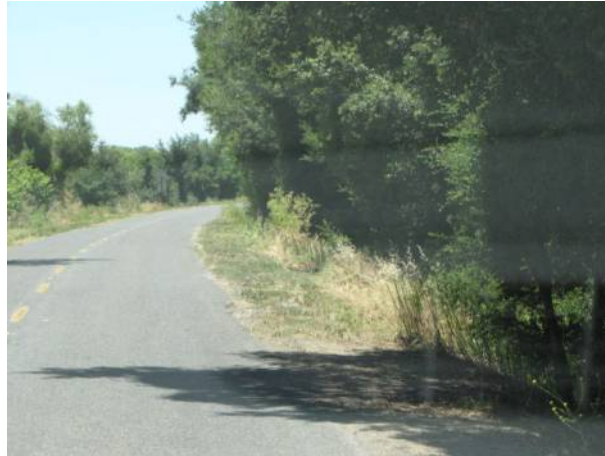
Levee Mile Report Line	1
Start Levee Mile	0.02
End Levee Mile	0.10
Location	Land Side
Category	Earthen Levee
Item	Vegetation

This shot shows the start of District landward.

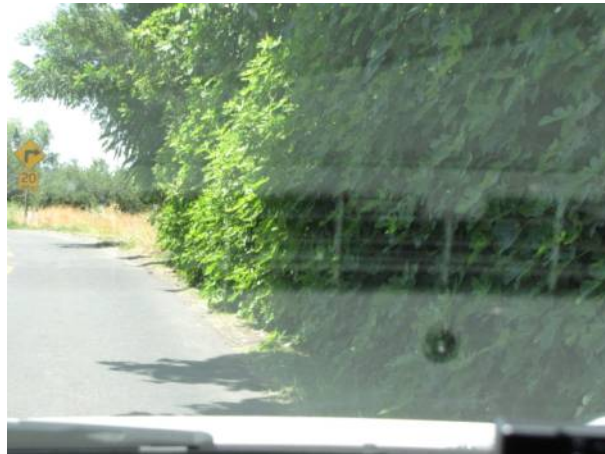
Levee Mile Report Line	8
Start Levee Mile	0.90
End Levee Mile	0.91
Location	Land Side
Category	Earthen Levee
Item	Trim / Thin Trees

Levee mile 0.90 landside wild tree growth on slope waterward.

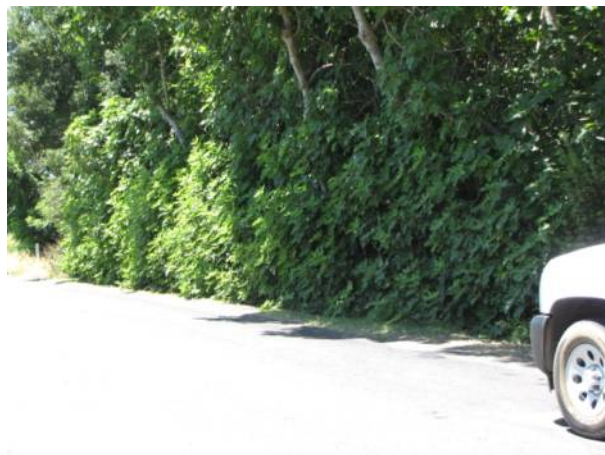
Levee Mile Report Line	8
Start Levee Mile	0.90
End Levee Mile	0.91
Location	Land Side
Category	Earthen Levee
Item	Trim / Thin Trees

Looking downstream at tree growth landward levee mile 0.91

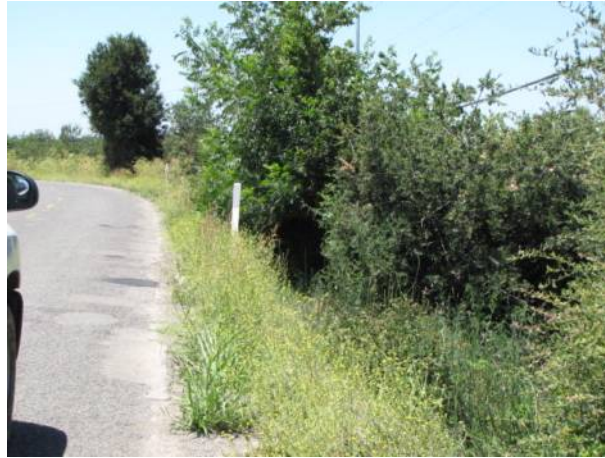
Levee Mile Report Line	10
Start Levee Mile	1.20
End Levee Mile	1.31
Location	Land Side
Category	Earthen Levee
Item	Trim / Thin Trees

Wild growth landward looking downstream from levee mile 1.20

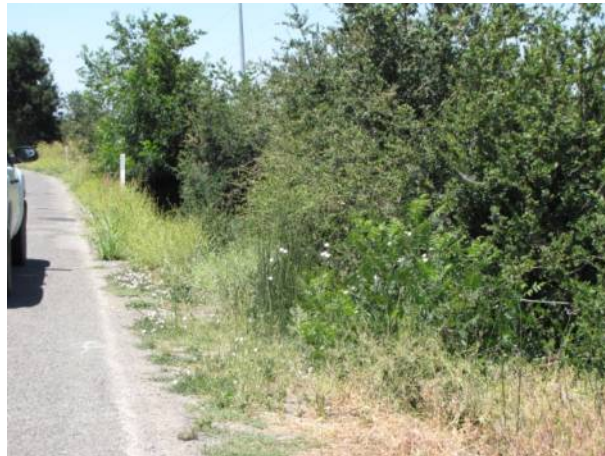
Levee Mile Report Line	10
Start Levee Mile	1.20
End Levee Mile	1.31
Location	Land Side
Category	Earthen Levee
Item	Trim / Thin Trees

Wild growth continues downstream to levee mile 1.31 land side.

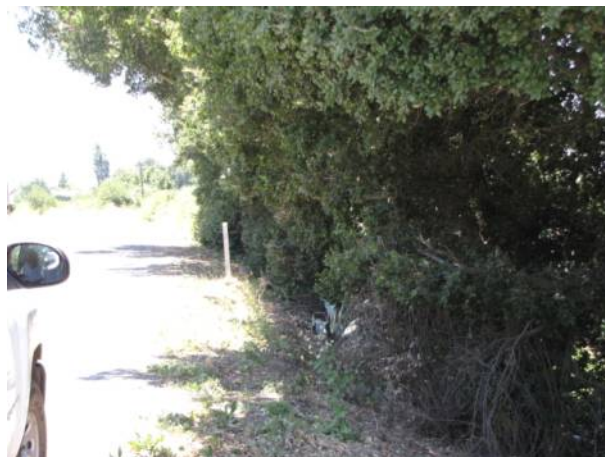
Levee Mile Report Line	11
Start Levee Mile	1.32
End Levee Mile	1.42
Location	Land Side
Category	Earthen Levee
Item	Trim / Thin Trees

Looking downstream landside at levee mile 1.32 growth of trees covering the slope and toe of the levee section.

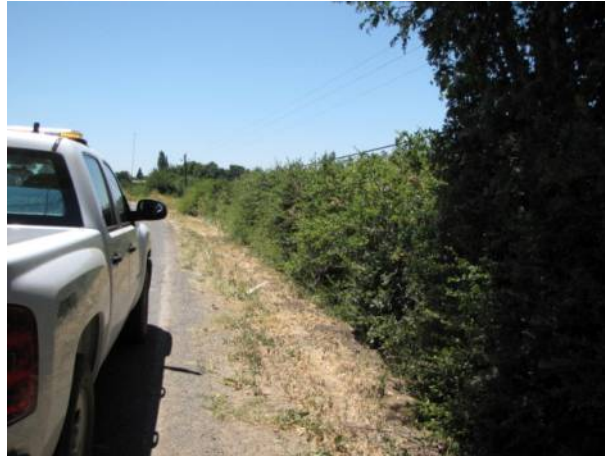
Levee Mile Report Line	11
Start Levee Mile	1.32
End Levee Mile	1.42
Location	Land Side
Category	Earthen Levee
Item	Trim / Thin Trees

Levee mile 1.35 the wild growth continues downstream you can't see the slopes for the wild growth.

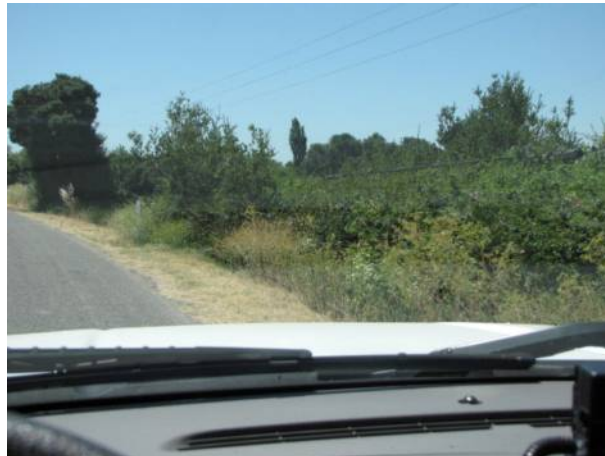
Levee Mile Report Line	11
Start Levee Mile	1.32
End Levee Mile	1.42
Location	Land Side
Category	Earthen Levee
Item	Trim / Thin Trees

Levee mile 1.41 wild growth continues on the land side levee slopes and toe.

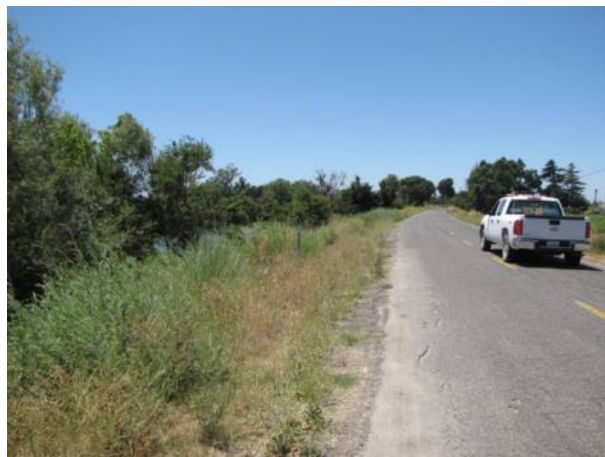
Levee Mile Report Line	18
Start Levee Mile	1.76
End Levee Mile	2.02
Location	Water Side
Category	Earthen Levee
Item	Vegetation

Water side levee mile 1.86 looking downstream towards levee 2.02. Young willow trees.

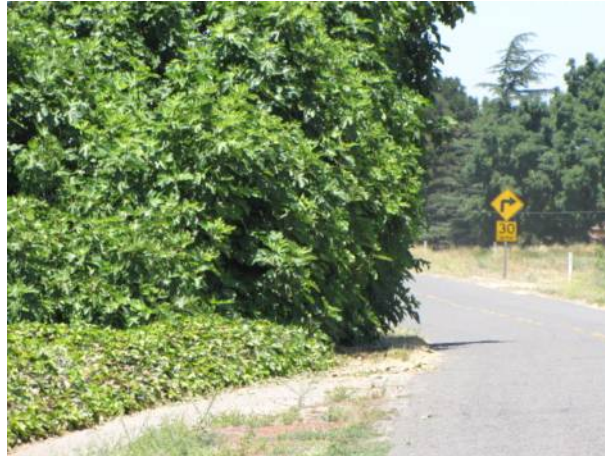
Levee Mile Report Line	23
Start Levee Mile	2.32
End Levee Mile	2.34
Location	Land Side
Category	Earthen Levee
Item	Trim / Thin Trees

Looking back upstream at Fig tree growth at levee mile 2.32 land side, these trees has covered the slope blocking inspection.

23	2.32	2.34	Earthen Levee	Trim / Thin Trees	LS	U	Trim trees to at least five feet above ground level.	38.219822 ° -121.544000 °	38.219592 ° -121.543927 °	24 Y
24	2.42	2.42	Earthen Levee	Vegetation	LS	M	Remove the wild growth other than native grasses from the levee slopes.	38.218373 ° -121.543847 °	38.218373 ° -121.543847 °	26
25	2.42	2.69	Earthen Levee	Encroachments	LS	PO	Buildings	38.218373 ° -121.543847 °	38.215230 ° -121.541147 °	28
26	2.46	2.50	Earthen Levee	Vegetation	LS	C	Remove the wild growth other than native grasses from the levee slopes.	38.217757 ° -121.543827 °	38.217285 ° -121.543693 °	82
27	2.47	2.48	Earthen Levee	Encroachments	LS	PO	Fences	38.217598 ° -121.543767 °	38.217462 ° -121.543710 °	99
28	2.52	2.54	Earthen Levee	Encroachments	LS	M	Tree or limb	38.216865 ° -121.543268 °	38.216987 ° -121.543358 °	4
29	2.54	2.54	Earthen Levee	Encroachments	LS	M	Tree or limb	38.216672 ° -121.543103 °	38.216673 ° -121.543102 °	7

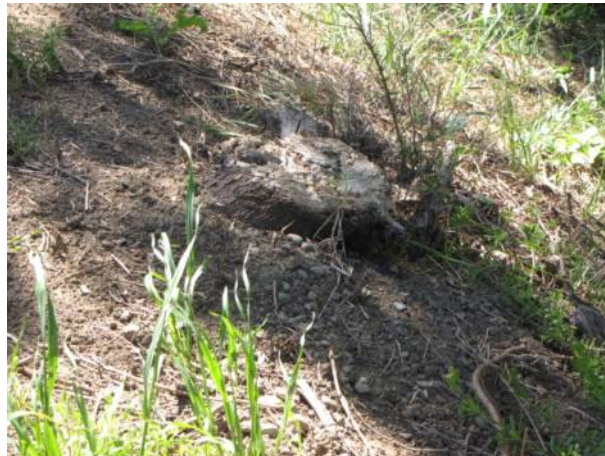
Levee Mile Report Line	36
Start Levee Mile	2.96
End Levee Mile	2.96
Location	Land Side
Category	Earthen Levee
Item	Trim / Thin Trees

This stump location is 32.212632 -121.537538 land side levee mile 2.96.

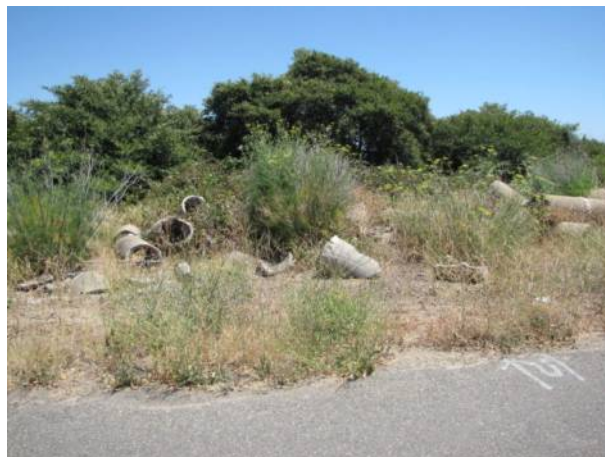
Levee Mile Report Line	48
Start Levee Mile	3.44
End Levee Mile	3.46
Location	Water Side
Category	Earthen Levee
Item	Encroachments

Unauthorized storage of discarded concrete pipe placed on the waterward side levee mile 3.44.

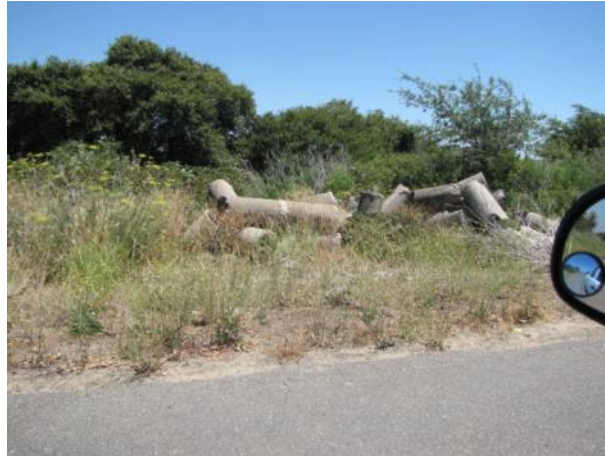
Levee Mile Report Line	48
Start Levee Mile	3.44
End Levee Mile	3.46
Location	Water Side
Category	Earthen Levee
Item	Encroachments

Discarded concrete pipe continues downstream water side levee mile 3.44

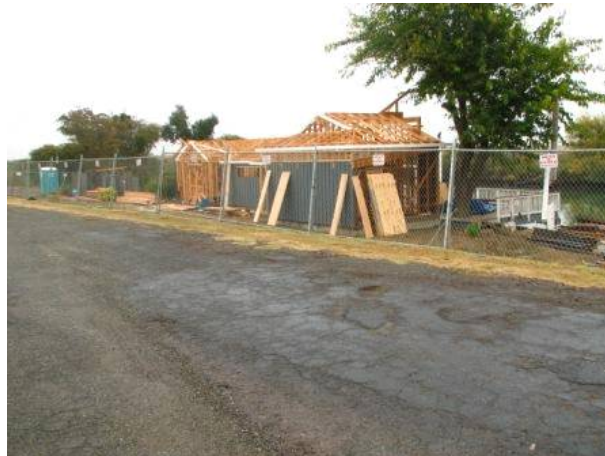
Levee Mile Report Line	57
Start Levee Mile	3.94
End Levee Mile	4.05
Location	Water Side
Category	Earthen Levee
Item	Encroachments

This house has been remodeled without a Reclamation Permit. At this time 12-09 this house has been complete and listed for sale.

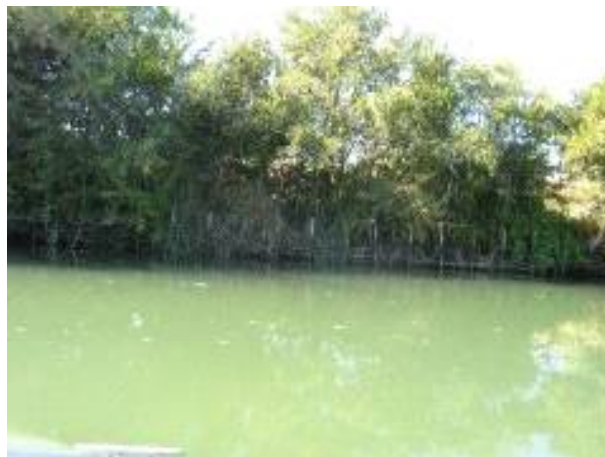
Levee Mile Report Line	69
Start Levee Mile	5.11
End Levee Mile	5.25
Location	Water Side
Category	Supplemental
Item	USACE Erosion Survey

2009: 5 ft berm, 1:1 slope, tree hazards, clays and silts, 3.88 ft/s [2009 SiteID:GEO_7-0_R]

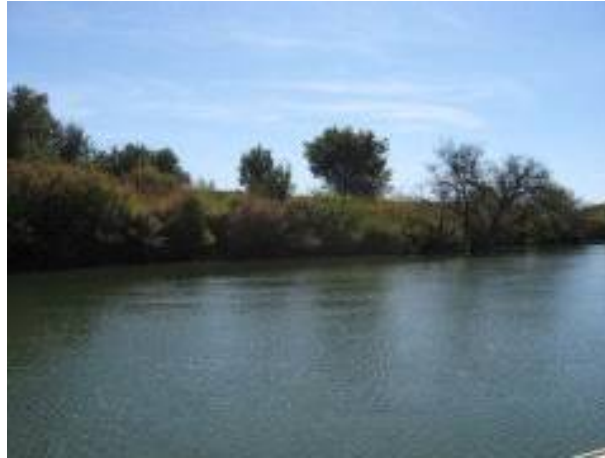
Levee Mile Report Line	3
Start Levee Mile	0.31
End Levee Mile	0.61
Location	Water Side
Category	Supplemental
Item	USACE Erosion Survey
2009: no berm, 1:1 slope, tree hazards, holes, and slumping, clays and silts, 5.13 ft/s [2009 SiteID:SAC_26-0_L]	
USACE2009_SAC_26-0_L_2009_09_17-D3bP49_small.JPG

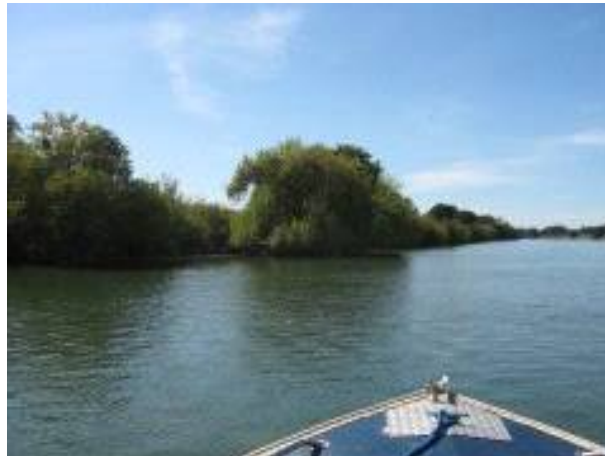
Levee Mile Report Line	4
Start Levee Mile	1.09
End Levee Mile	1.15
Location	Water Side
Category	Supplemental
Item	USACE Erosion Survey
2009: 10 ft berm, 1:1 slope, tree hazards and slumping, clays and silts, 4.54 ft/s [2009 SiteID:SAC_25-2_L]	
USACE2009_SAC_25-2_L_2009_09_17-D3bP53_small.JPG

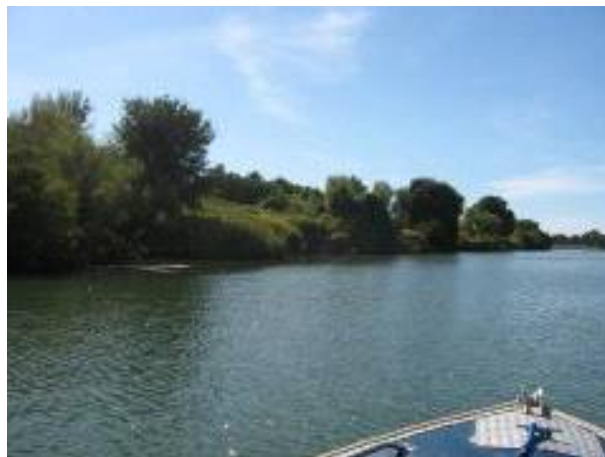
Levee Mile Report Line	5
Start Levee Mile	1.44
End Levee Mile	1.59
Location	Water Side
Category	Supplemental
Item	USACE Erosion Survey
2009: 10 ft berm, 2:1 slope, tree hazards and slumping, sands and silts, 4.5 ft/s [2009 SiteID:SAC_24-8_L]	
USACE2009_SAC_24-8_L_2009_09_17-D3bP54_small.JPG

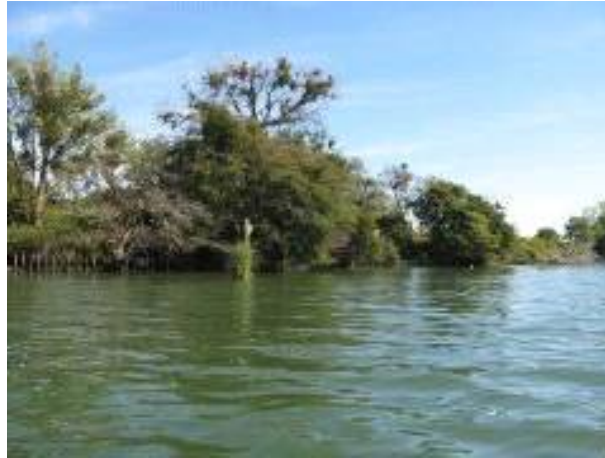
Levee Mile Report Line	15
Start Levee Mile	3.16
End Levee Mile	3.27
Location	Water Side
Category	Supplemental
Item	USACE Erosion Survey
2009: 10 ft berm, 1:1 slope, tree hazards, holes, and slumping, clays and silts, 4.16 ft/s [2009 SiteID:SAC_23-2_L]	
USACE2009_SAC_23-2_L_2009_09_17-D3bP57_small.JPG

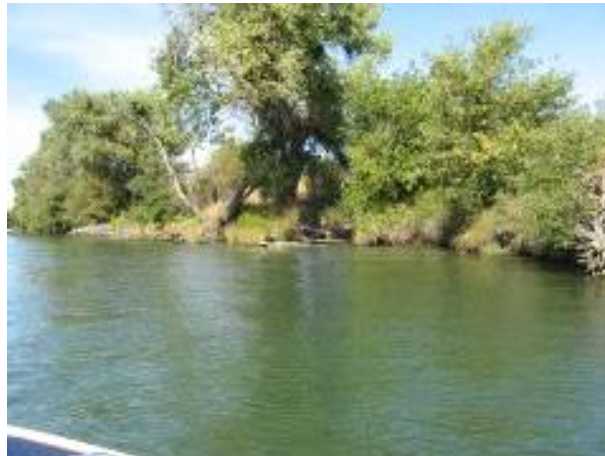
Levee Mile Report Line	17
Start Levee Mile	3.57
End Levee Mile	3.63
Location	Water Side
Category	Supplemental
Item	USACE Erosion Survey
2009: no berm, 1.5:1 slope, tree hazards, clays and silts, 4.82 ft/s [2009 SiteID:SAC_22-7_L]	
USACE2009_SAC_22-7_L_2009_09_17-D3bP58_small.JPG

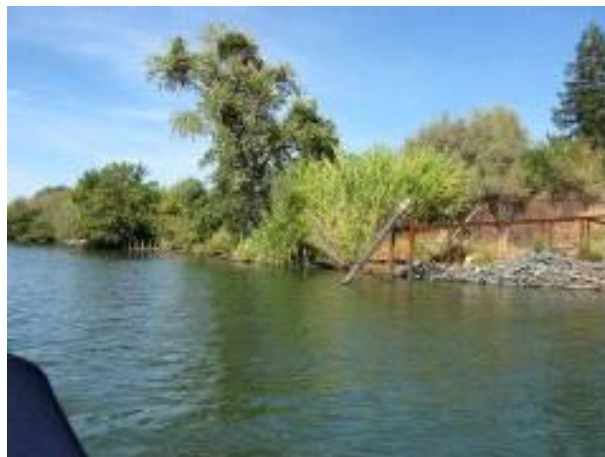
Levee Mile Report Line	19
Start Levee Mile	3.94
End Levee Mile	4.11
Location	Water Side
Category	Supplemental
Item	USACE Erosion Survey
2009: 10 ft berm, 1:1 slope, tree hazards, holes, and slumping, sands and silts, 4.54 ft/s [2009 SiteID:SAC_22-5_L]	
USACE2009_SAC_22-5_L_2009_09_17-D3bP60_small.JPG

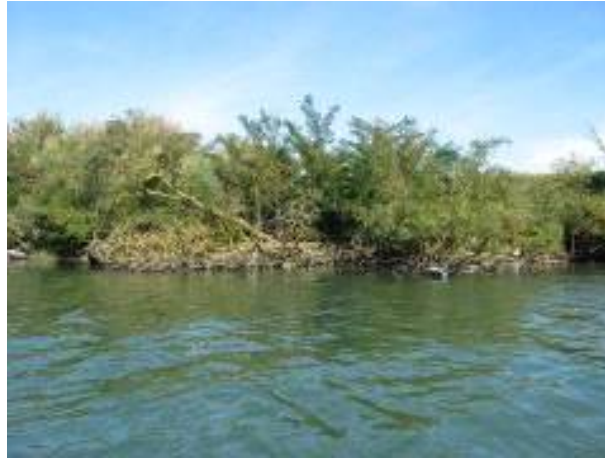
Levee Mile Report Line	33
Start Levee Mile	4.84
End Levee Mile	4.88
Location	Water Side
Category	Supplemental
Item	USACE Erosion Survey
2009: 5 ft berm, 1.5:1 slope, tree hazards, clays and silts, 4.3 ft/s [2009 SiteID:SAC_21-5_L]	
USACE2009_SAC_21-5_L_2009_09_17-D3bP61_small.JPG
